June 18, 2018

Re: Lake Park Arch Bridge over Ravine Road – Phase 2: Concrete Testing Results

Subject: Presentation of test data for existing concrete for
Lake Park Footbridge over Ravine Road
Milwaukee, Wisconsin
Giles Project No. 1M-1803020-REV

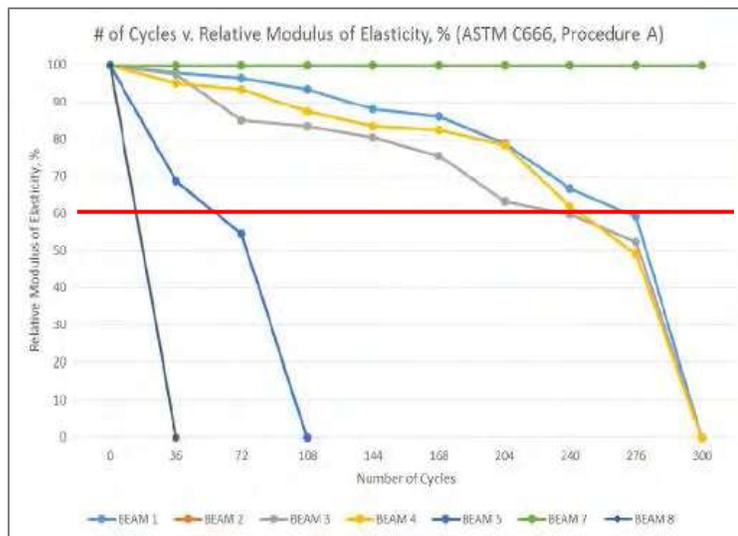
Figure 1 – Freeze-thaw analysis test results (from Giles Engineering Associates, Inc. report dated June 14, 2018).

The results of the freeze-thaw analysis confirmed that without an effective air-entrained void system, the relative dynamic modulus of elasticity reduced quickly when subjected to numerous freeze-thaw cycles. According to ASTM C666, the specimens being tested are subjected to cycles of freezing and thawing, and their frequencies are then measured to determine the change in relative modulus as a function of these cycles. The tests are to be continued until the specimen reaches the desired 300 cycles or until its relative dynamic modulus of elasticity is drops below 60% of the initial modulus, whichever comes first, unless other limits are specified.

Based on the test results, the relative dynamic modulus of Beams 2 and 8 (center floorbeam and west arch rib, respectively) reduced to zero after the initial 36 cycles. The relative modulus of Beam 5 (west spandrel wall) dropped below the 60% threshold between 72 and 108 cycles. Beam 1 (top of east parapet), Beam 3 (first floorbeam north of midspan), and Beam 4 (east arch rib near south thrust block) dropped below the 60% threshold between 240 and 276 cycles. Beam 7 (south thrust block) did not experience any notable reduction in its dynamic modulus of elasticity and remained in good condition over the full 300 freeze-thaw cycle; this is because Beam 7 consisted of modern concrete with an effective air-entrained void system which allows for water trapped within the concrete to freeze and thaw freely without causing damage.

Although WisDOT does not have a specification for relative dynamic modulus of elasticity or durability factor, the United States Army Corps of Engineers and Federal Aviation Administration typically require projects to have a relative dynamic modulus of elasticity greater than 75% for new concrete. All beam samples except Beam 7 fell below this targeted threshold for modern job mix formulas for concrete. This would be expected with concrete from this era which lacks an effective air void system to accommodate freeze-thaw cycles within the specimens. However, while these test results suggest that the original concrete has a less than desirable resistance to freeze-thaw cycles, the testing procedure clearly states that “neither procedure [from ASTM C666] is intended to provide a quantitative measure of the length of service that may be expected from a specific type of concrete.” As a result, the remaining service life of the concrete cannot be concluded from this freeze-thaw analysis.

While the freeze-thaw analysis shows that the bridge has less than desirable durability against cycles of freezing and thawing, this is not an indicator of the structural integrity of the bridge. The compressive strength of the structure dictates the load-carrying capacity of the bridge. Chloride content and the petrographic analysis provide information regarding the condition of the structure and possible deterioration that has occurred over time. The lack of freeze-thaw resistance in this structure can be partially mitigated by reducing the infiltration of water inside structural members, which can be done by sealing the concrete surfaces or improving the drainage system on the structure.

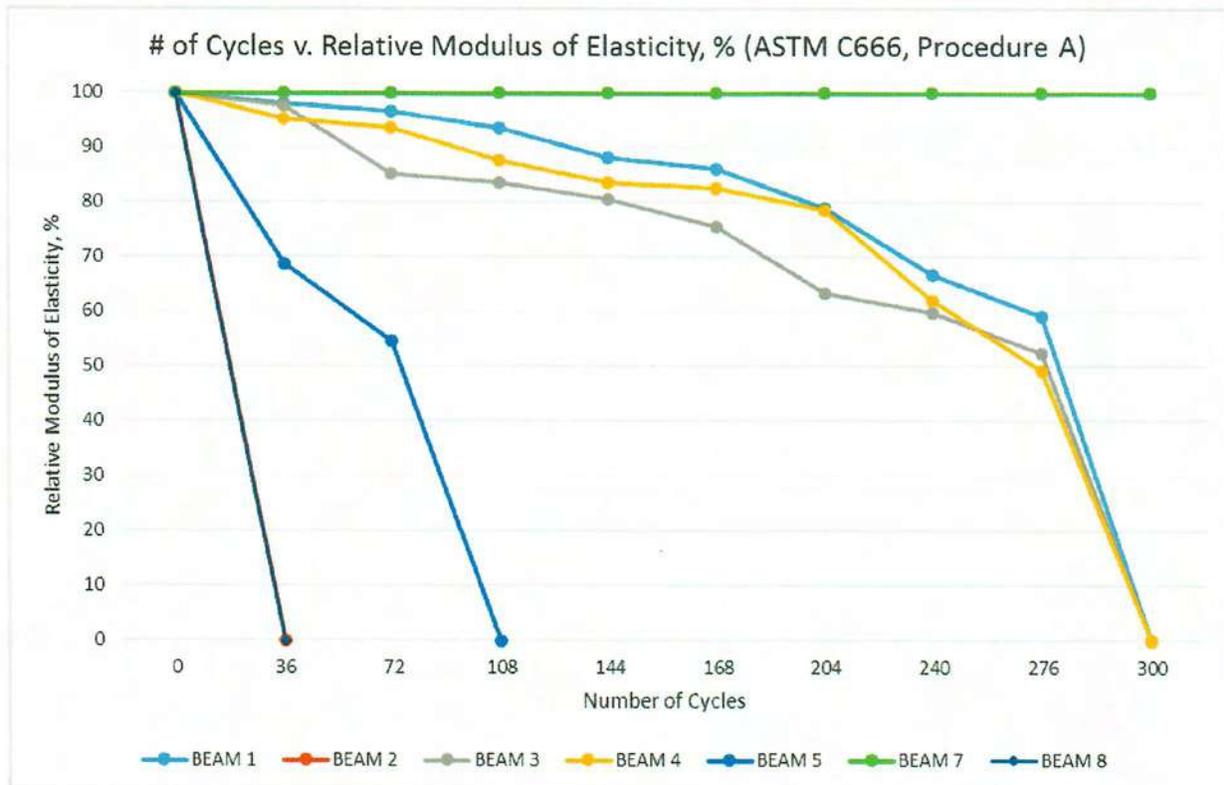
For this test, a sample is considered to have failed the parameters of the test if readings fall below 60 percent of the initial modulus. Beams 2 and 8 degraded prior to the conclusion of the initial 36 cycles to the degree that the remaining specimens were untestable. Beam 5 results fell below 60 percent of the initial modulus between 36 and 72 cycles. Beams 1, 3, and 4 fell below 60 percent between 240 and 276 cycles (beams 3 and 4 probably toward the earlier portion and beam 1 in the latter portion of that 36-cycle interval). Beam 7 (which consisted of a modern era concrete patch) did not exhibit a change in readings through the full 300 cycles. The picture below depicts the test results in graphic form. The lines for beams 2 and 8 coincide on the graph, going from 100 to 0 percent after 36 cycles.

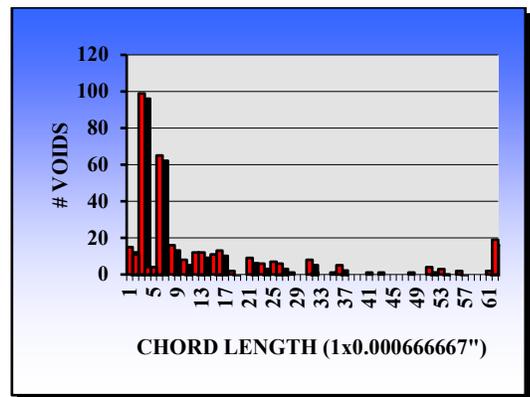
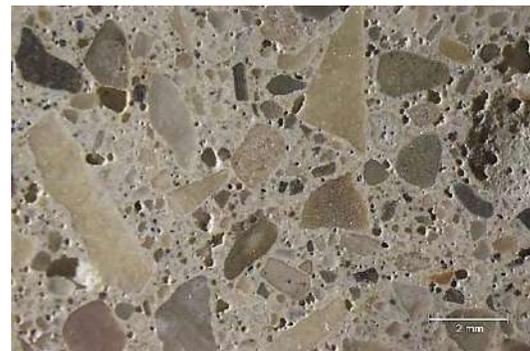
Sample ID: #3
Conformance: The concrete contains an air void system which is not consistent with current American Concrete Institute (ACI) recommendations for freeze-thaw resistance.

Test Data: By ASTM C457, Procedure A
Air Void Content % 4.1
Entrained, % < 0.040"(1mm) 2.7
Entrapped, % > 0.040"(1mm) 1.4
Air Voids/inch 3.8
Specific Surface, in²/in³ 370
Spacing Factor, inches 0.014
Paste Content, % estimated 25
Magnification 75x
Traverse Length, inches 90
Test Date 4/25/2018
Test Performed By W. Reely

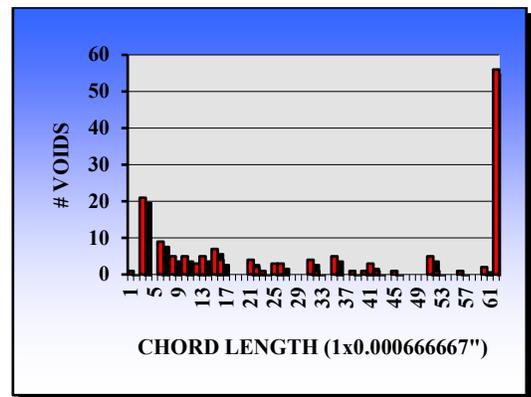
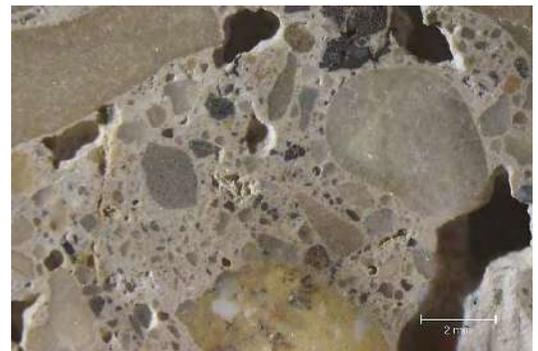
The concrete contains an air void system which is not consistent with current American Concrete Institute (ACI) recommendations for freeze-thaw resistance.

Air Void Content %	8.2
Entrained, % < 0.040"(1mm)	1.4
Entrapped, % > 0.040"(1mm)	6.8
Air Voids/inch	1.7
Specific Surface, in ² /in ³	80
Spacing Factor, inches	0.032
Paste Content, % estimated	22
Magnification	75x
Traverse Length, inches	90
Test Date	4/25/2018
Test Performed By	W. Reely

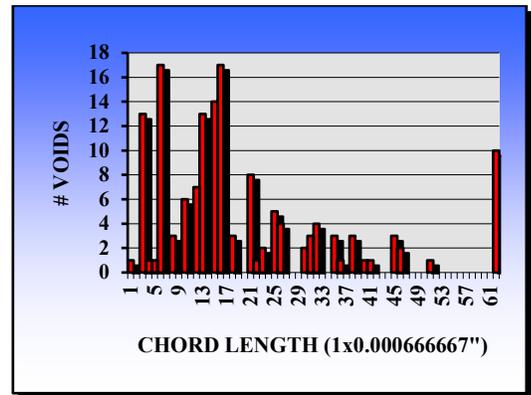
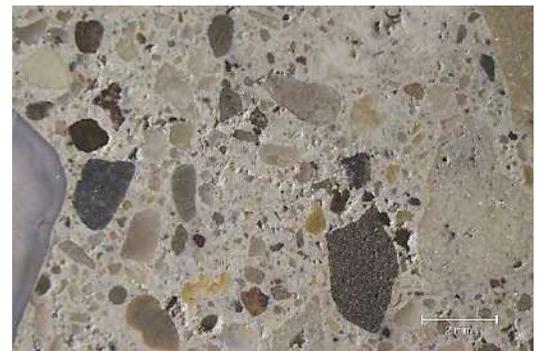
Sample ID: #9
Conformance: The concrete contains an air void system which is not consistent with current American Concrete Institute (ACI) recommendations for freeze-thaw resistance.

Air Void Content %	2.5
Entrained, % < 0.040"(1mm)	1.8
Entrapped, % > 0.040"(1mm)	0.7
Air Voids/inch	1.7
Specific Surface, in ² /in ³	270
Spacing Factor, inches	0.024
Paste Content, % estimated	26
Magnification	75x
Traverse Length, inches	90
Test Date	4/26/2018
Test Performed By	W. Reely

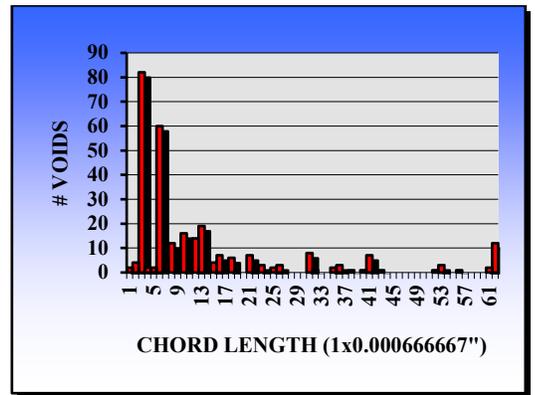
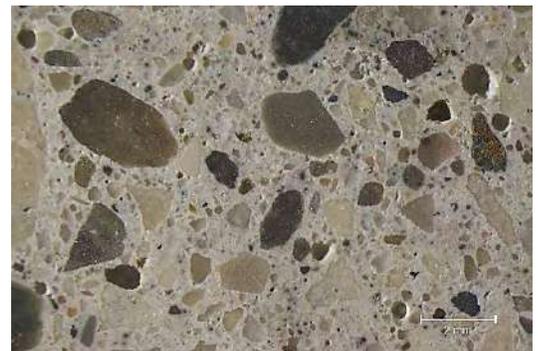
Sample ID: #12
Conformance: The concrete contains an air void system which is not consistent with current American Concrete Institute (ACI) recommendations for freeze-thaw resistance.

Test Data: By ASTM C457, Procedure A
Air Void Content % 3.7
Entrained, % < 0.040"(1mm) 2.4
Entrapped, % > 0.040"(1mm) 1.3
Air Voids/inch 3.2
Specific Surface, in²/in³ 350
Spacing Factor, inches 0.016
Paste Content, % estimated 28
Magnification 75x
Traverse Length, inches 90
Test Date 4/26/2018
Test Performed By W. Reely

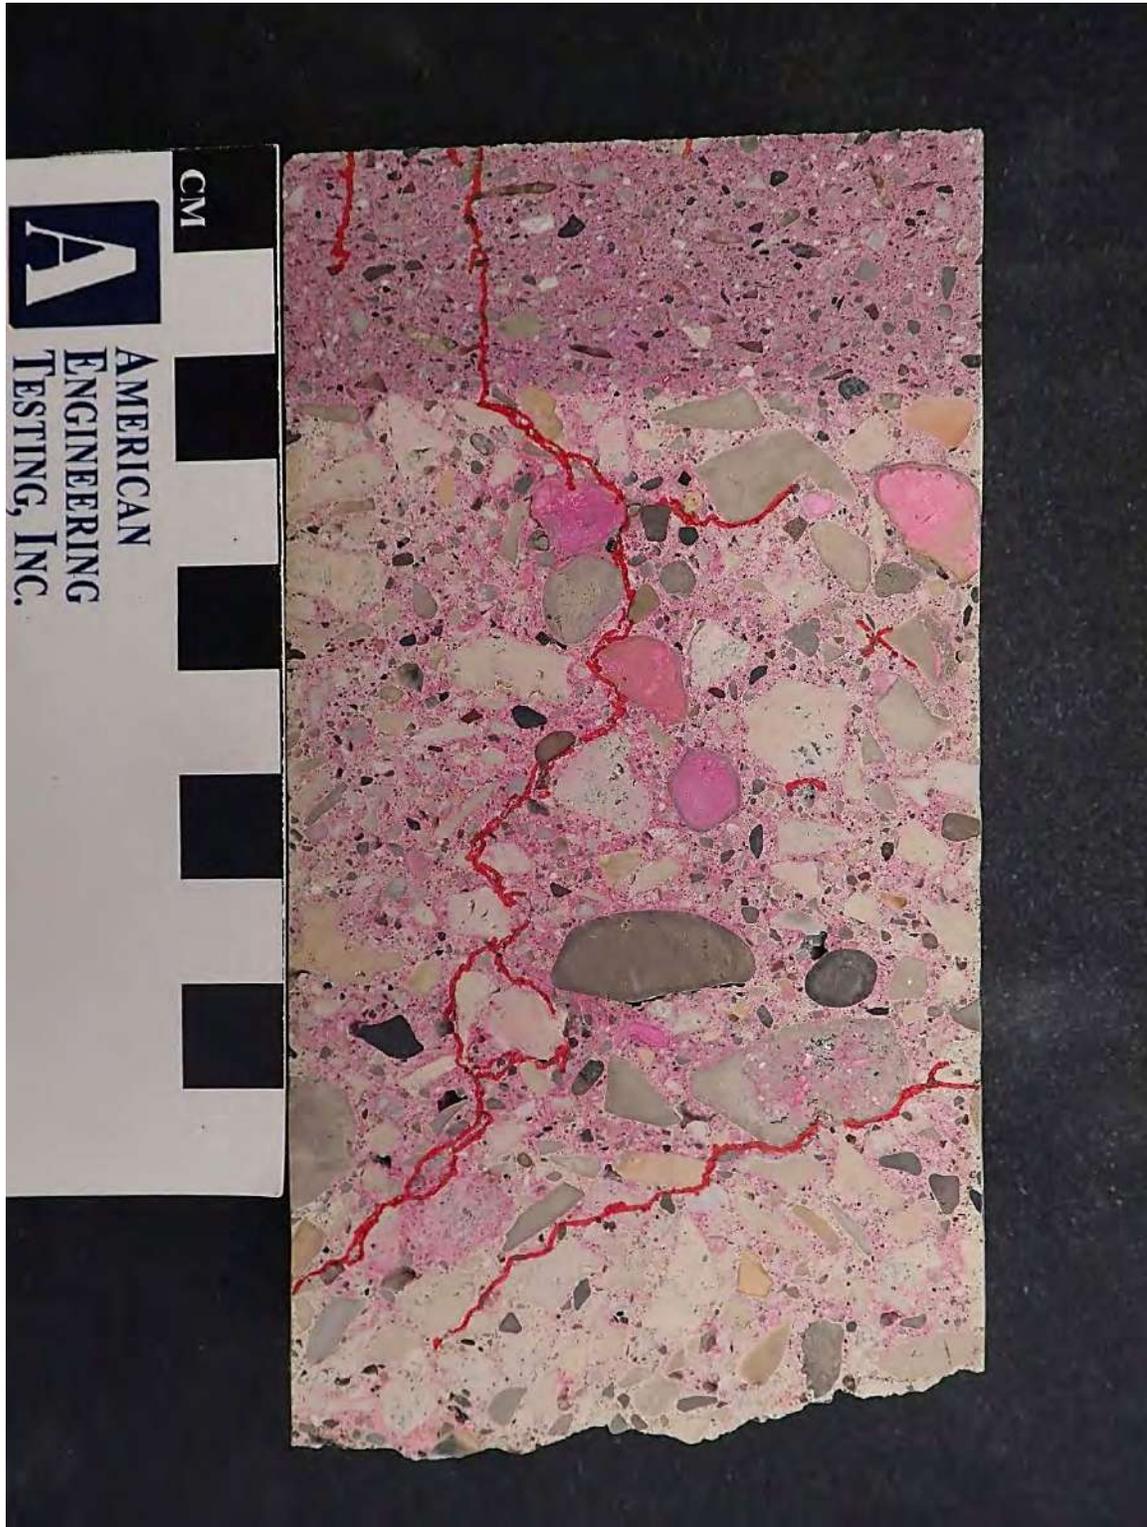
PHOTO: 9

DESCRIPTION: Freshly saw-cut and lapped profile of the core with the top surface oriented up, after application of phenolphthalein pH indicator. The pale pink stain of the base concrete indicates partial carbonation throughout its depth. Micro-cracking was mapped with red ink

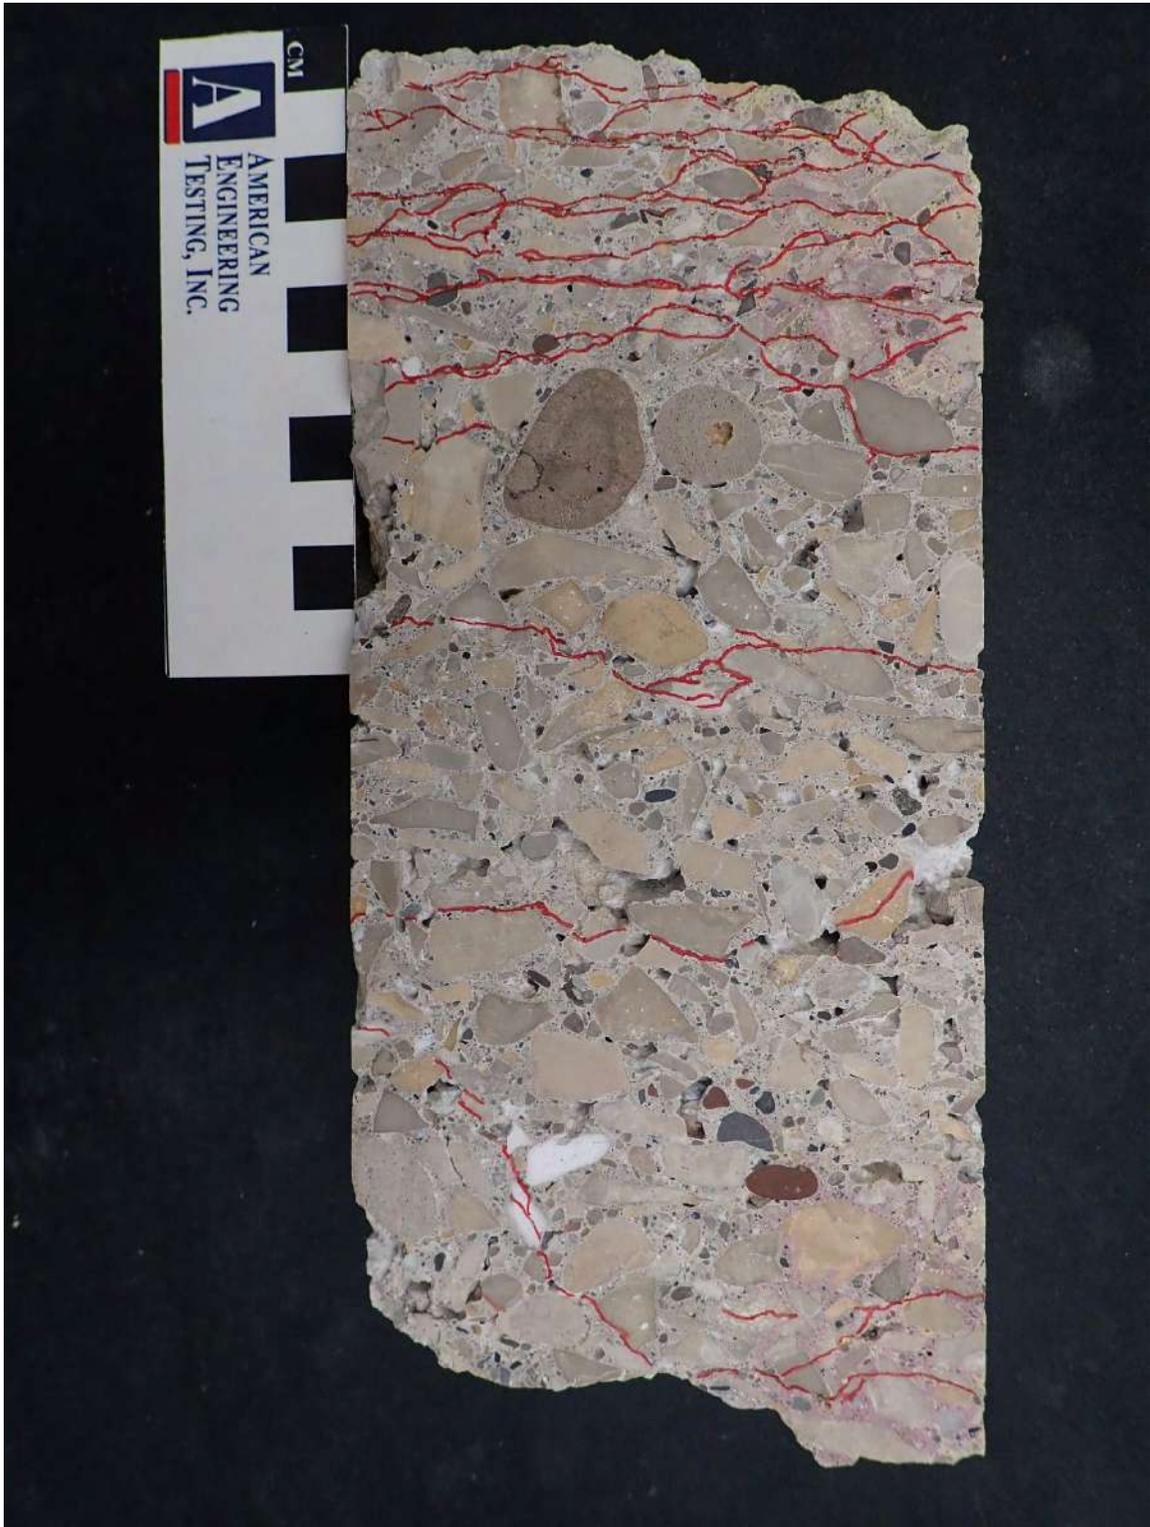
PHOTO: 10

DESCRIPTION: Freshly saw-cut and lapped profile of the core with the top surface oriented up. Phenolphthalein pH indicator (pink stain) was applied to the top and bottom right corners to check for carbonation. Macro-cracking and micro-cracking was mapped with red ink. Note the irregular consolidation voids.

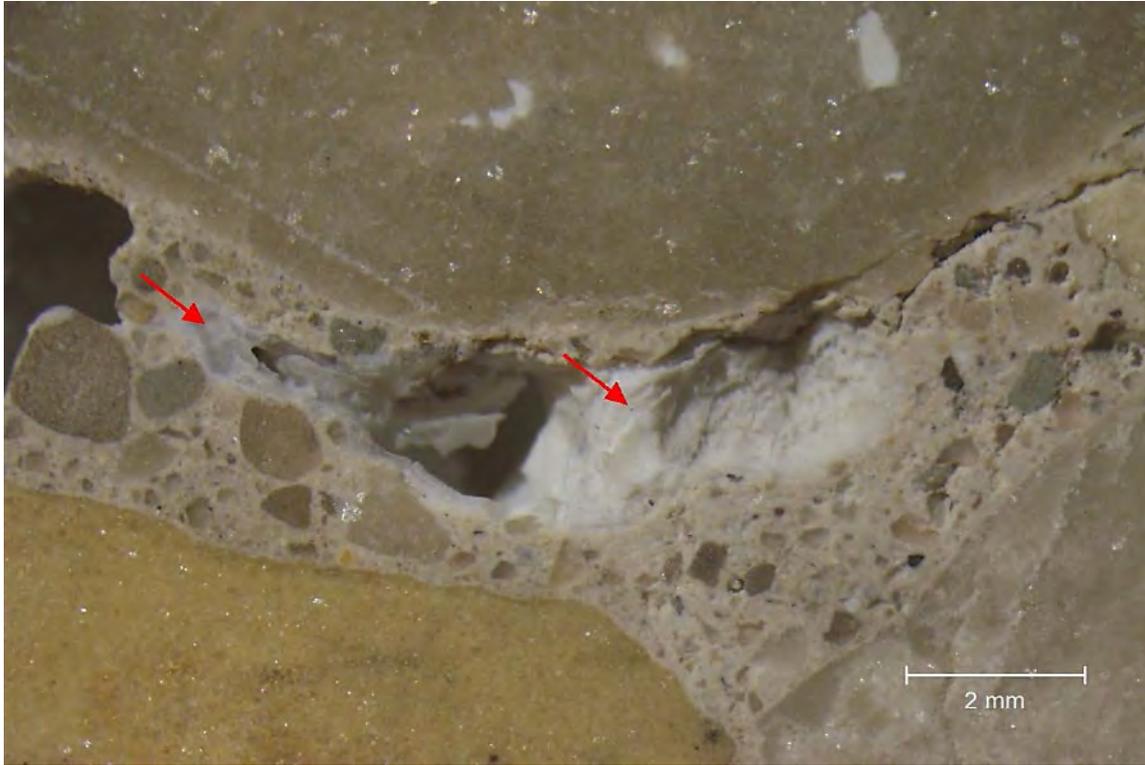
PHOTO: 11

SAMPLE ID: 7
MAG: 15x DESCRIPTION: White alkali-silica gel (red arrows) partially filling an irregular consolidation void.

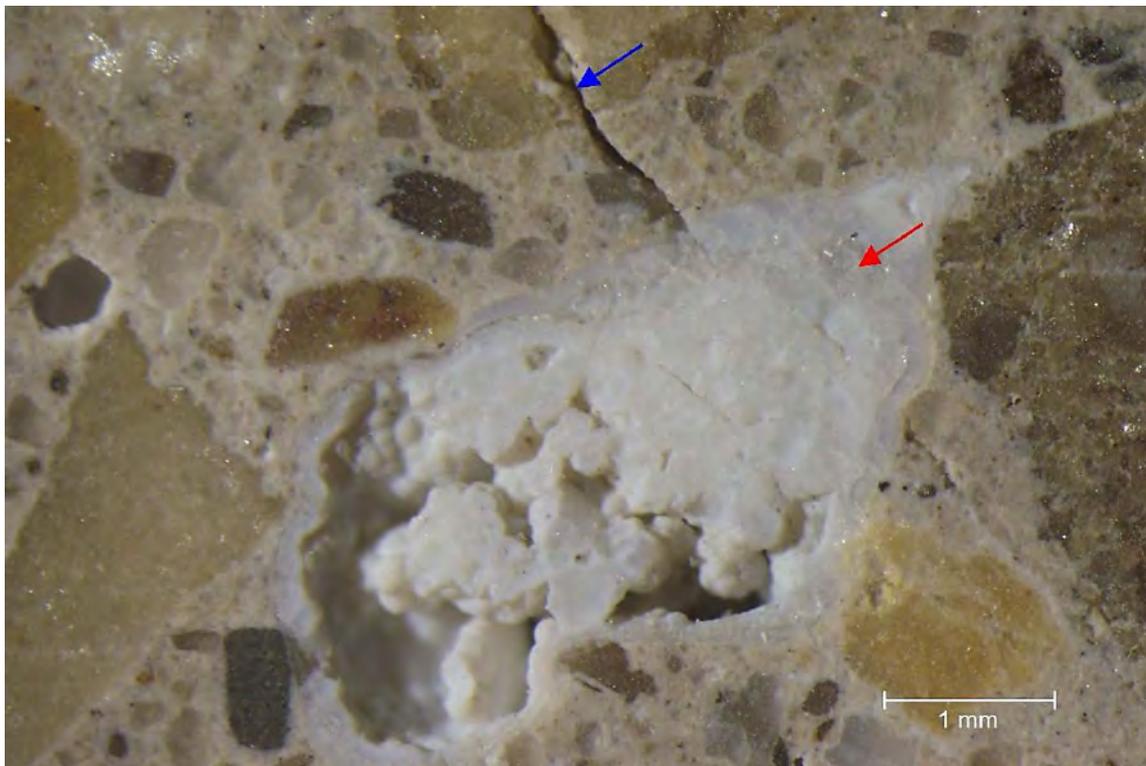
PHOTO: 12

SAMPLE ID: 7
MAG: 30x DESCRIPTION: White alkali-silica gel partially filling an entrapped-sized air void (red arrow), intersected by a micro-crack which propagated through a proximal limestone aggregate particle with a gel "plug" blue arrow) forming in the crack at the outer surface of the particle.

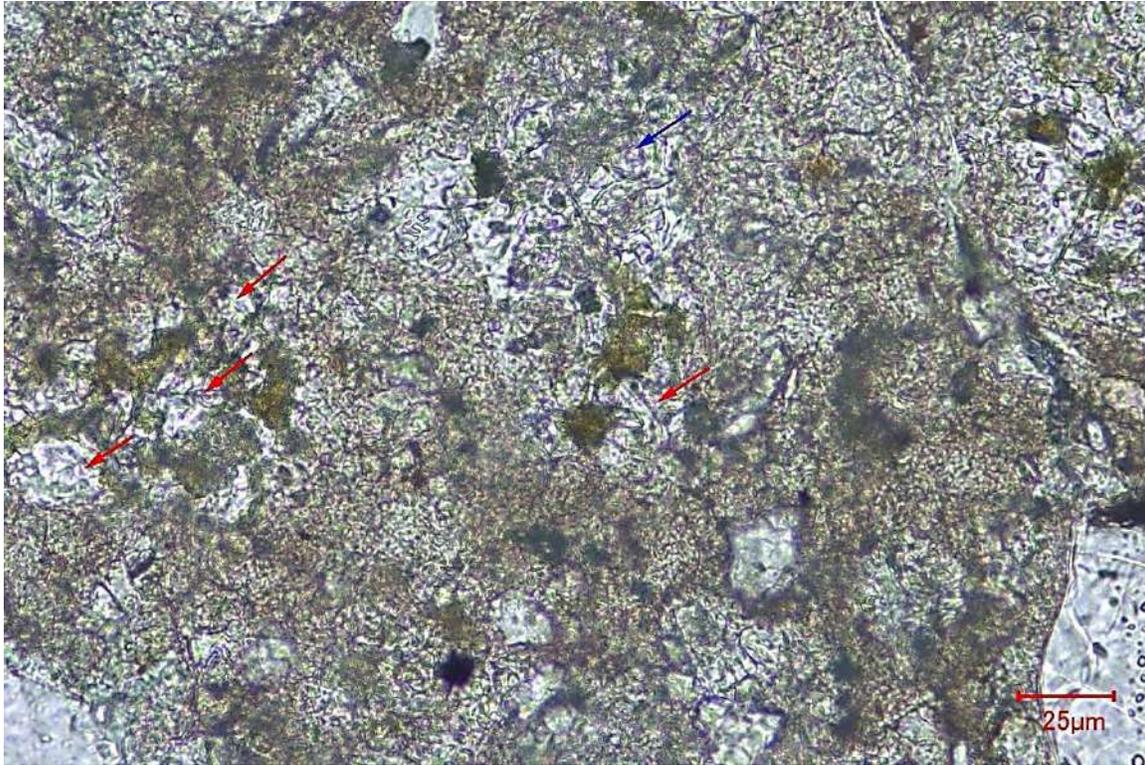
PHOTO: 15

DESCRIPTION: Fully-hydrated alite relicts (red arrows) and fully-hydrated belite relict (blue arrows) portland cement clinker particles, in a thin section of concrete, viewed under plane-polarized light.
