October 31, 2017

### RE: Structural Documentation Review of Lake Park Arch Bridge – Phase 1

June 18, 2018

**Re: Lake Park Arch Bridge over Ravine Road – Phase 2: Concrete Testing Results**

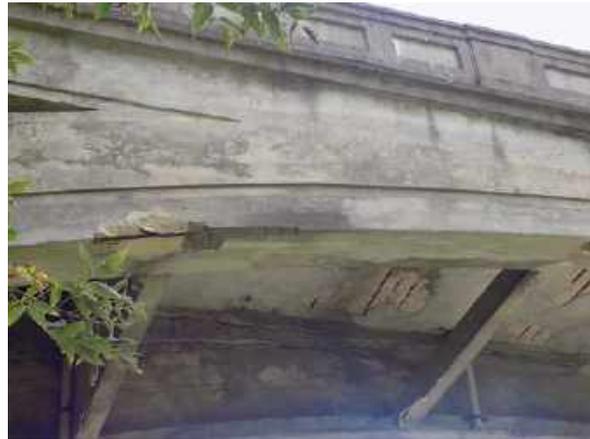
**Photo 2:** Corner spalls with exposed reinforcing steel on the arch rib

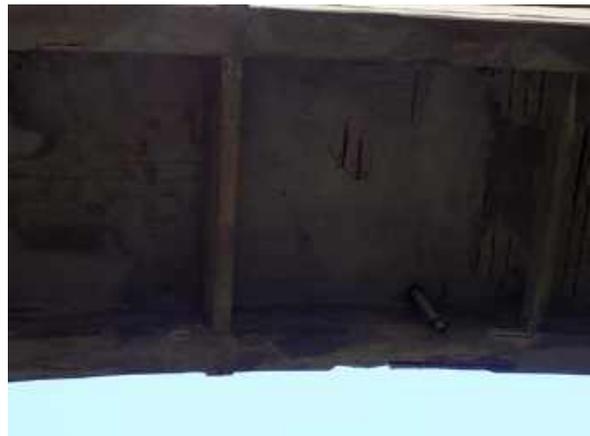
**Photo 3:** Underside of deck with delaminations

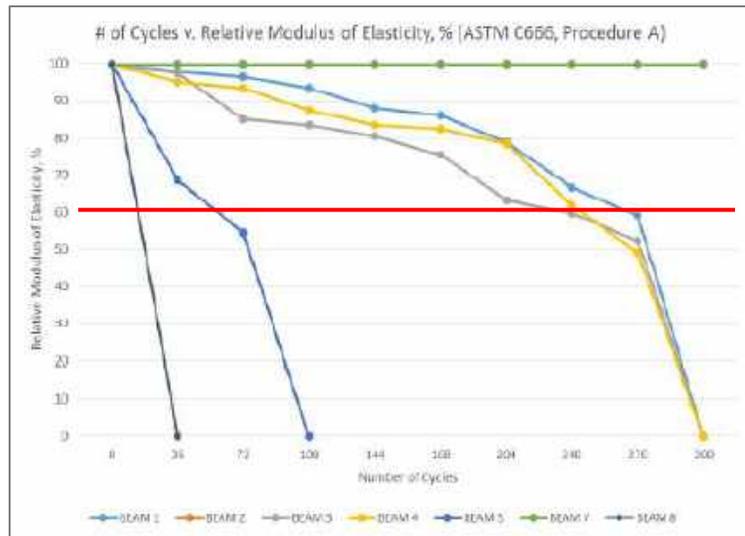
Figure 1 – Freeze-thaw analysis test results (from Giles Engineering Associates, Inc. report dated June 14, 2018).

The results of the freeze-thaw analysis confirmed that without an effective air-entrained void system, the relative dynamic modulus of elasticity reduced quickly when subjected to numerous freeze-thaw cycles. According to ASTM C666, the specimens being tested are subjected to cycles of freezing and thawing, and their frequencies are then measured to determine the change in relative modulus as a function of these cycles. The tests are to be continued until the specimen reaches the desired 300 cycles or until its relative dynamic modulus of elasticity is drops below 60% of the initial modulus, whichever comes first, unless other limits are specified.

Based on the test results, the relative dynamic modulus of Beams 2 and 8 (center floorbeam and west arch rib, respectively) reduced to zero after the initial 36 cycles. The relative modulus of Beam 5 (west spandrel wall) dropped below the 60% threshold between 72 and 108 cycles. Beam 1 (top of east parapet), Beam 3 (first floorbeam north of midspan), and Beam 4 (east arch rib near south thrust block) dropped below the 60% threshold between 240 and 276 cycles. Beam 7 (south thrust block) did not experience any notable reduction in its dynamic modulus of elasticity and remained in good condition over the full 300 freeze-thaw cycle; this is because Beam 7 consisted of modern concrete with an effective air-entrained void system which allows for water trapped within the concrete to freeze and thaw freely without causing damage.

While the freeze-thaw analysis shows that the bridge has less than desirable durability against cycles of freezing and thawing, this is not an indicator of the structural integrity of the bridge. The compressive strength of the structure dictates the load-carrying capacity of the bridge. Chloride content and the petrographic analysis provide information regarding the condition of the structure and possible deterioration that has occurred over time. The lack of freeze-thaw resistance in this structure can be partially mitigated by reducing the infiltration of water inside structural members, which can be done by sealing the concrete surfaces or improving the drainage system on the structure.

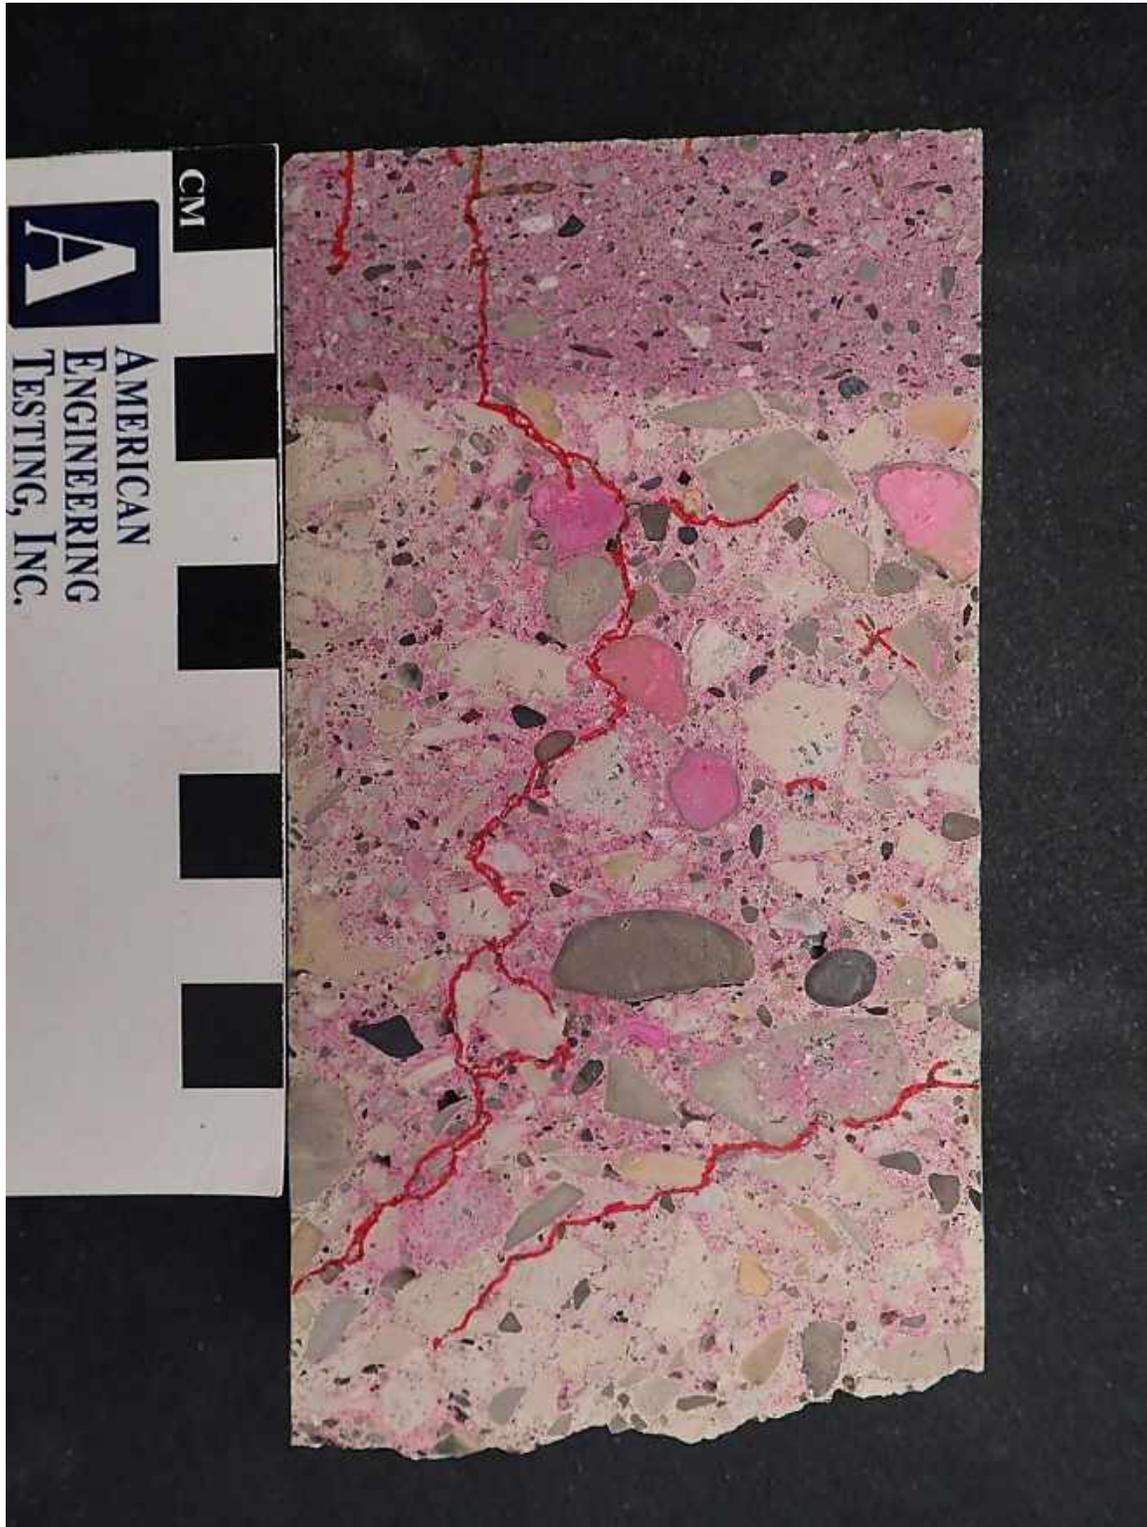
PHOTO: 9

**DESCRIPTION:** Freshly saw-cut and lapped profile of the core with the top surface oriented up, after application of phenolphthalein pH indicator. The pale pink stain of the base concrete indicates partial carbonation throughout its depth. Micro-cracking was mapped with red ink

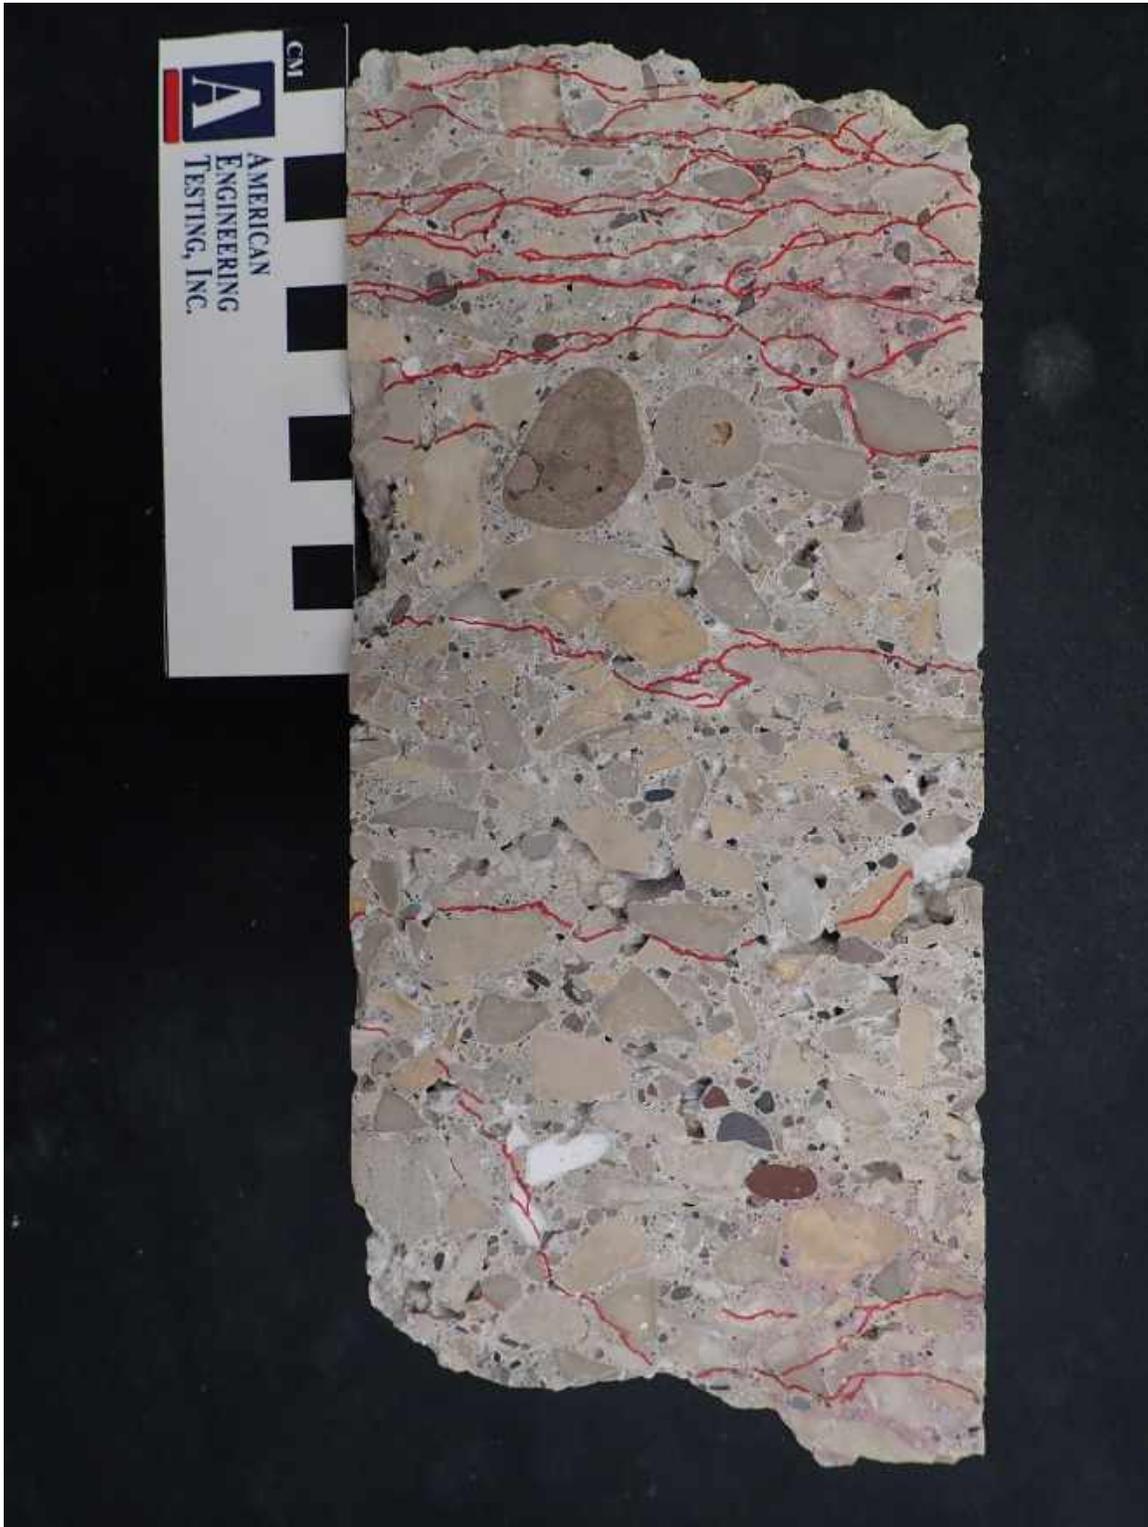
PHOTO: 10

**DESCRIPTION:** Freshly saw-cut and lapped profile of the core with the top surface oriented up. Phenolphthalein pH indicator (pink stain) was applied to the top and bottom right corners to check for carbonation. Macro-cracking and micro-cracking was mapped with red ink. Note the irregular consolidation voids.

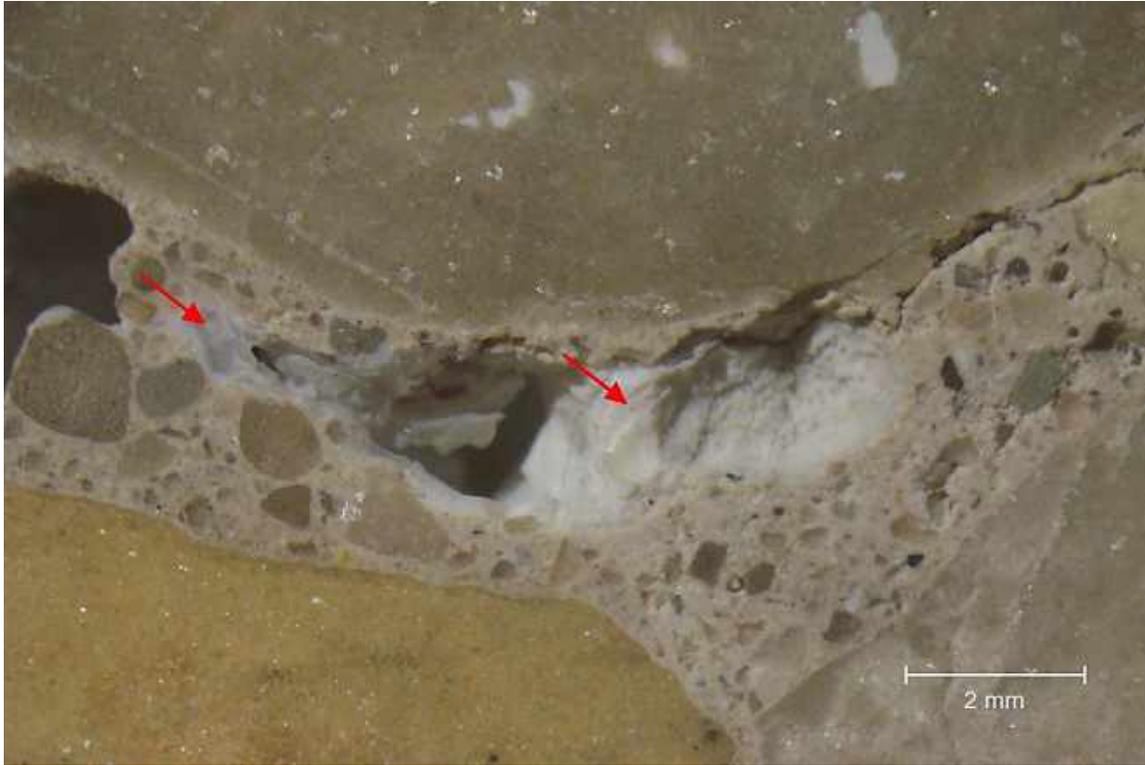
PHOTO: 11

DESCRIPTION: White alkali-silica gel (red arrows) partially filling an irregular consolidation void.

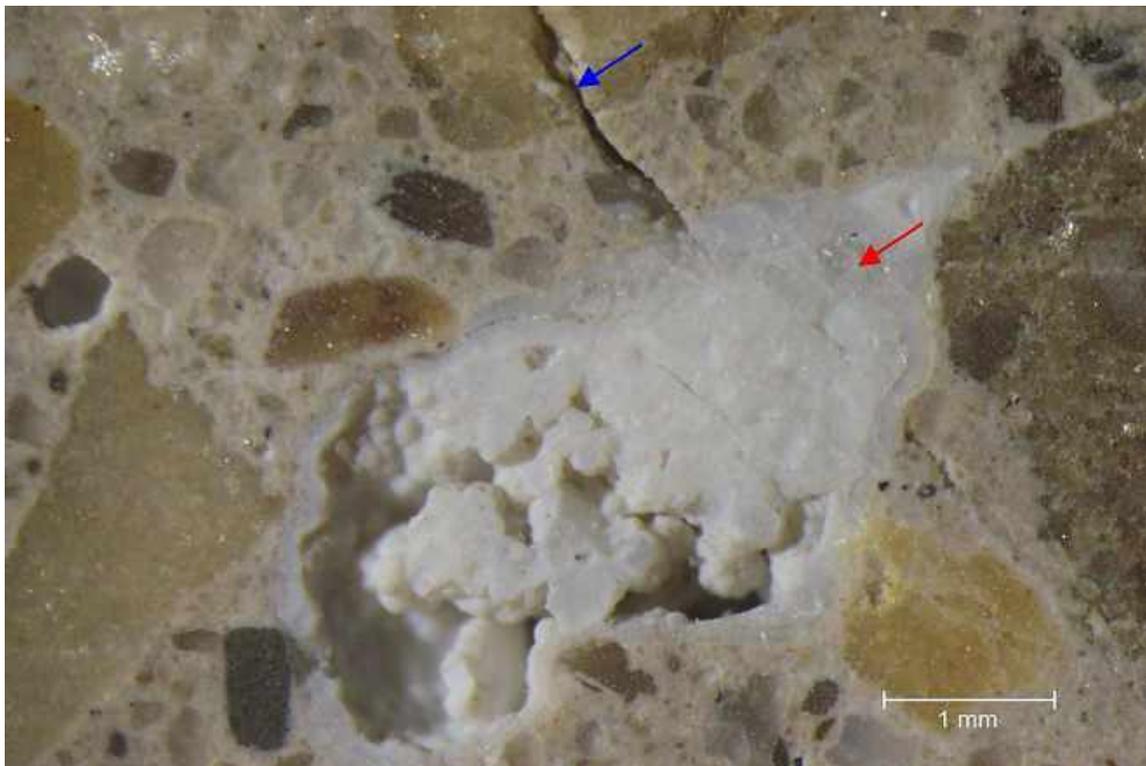
PHOTO: 12

DESCRIPTION: White alkali-silica gel partially filling an entrapped-sized air void (red arrow), intersected by a micro-crack which propagated through a proximal limestone aggregate particle with a gel "plug" blue arrow) forming in the crack at the outer surface of the particle.
