TranSystems

RE: Structural Documentation Review of Lake Park Arch Bridge – Phase 1

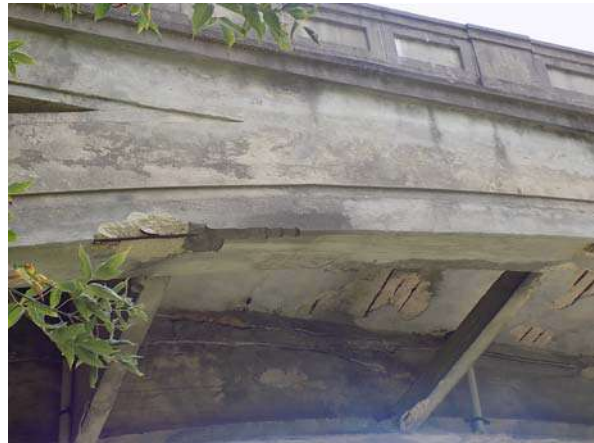
Photo 2: Corner spalls with exposed reinforcing steel on the arch rib

1. **CHLORIDE ION ANALYSIS** - Chloride contents at shallow depths of approximately 1½” (relative to the face of the core) within a core sample are generally indicative of chloride penetration from external sources such as road salt, airborne pollutants, or pollutants present in soil. In comparison, the chloride contents at deeper locations in a core sample may be more indicative of the as-built chloride content of the concrete. Large concentrations of chlorides within the concrete near the steel reinforcement promote corrosion of the reinforcement and will determine the effectiveness of any cathodic protection systems or health monitoring systems installed during rehabilitation. Spalling of the concrete may result from ongoing steel reinforcement corrosion.

2. **PETROGRAPHIC ANALYSIS** - Petrographic analysis is used to identify if an alkali-silica reaction (ASR) is occurring between the minerals in the aggregates and the soluble alkaline components of the cement paste. ASR was poorly understood at the time this bridge was constructed. ASR weakens the cement bond to the large particles within concrete. The presence of ASR will limit the durability of repairs made to the existing concrete bridge, however better concrete mix formulas for the repair areas will ensure compatibility between the two types of concrete.

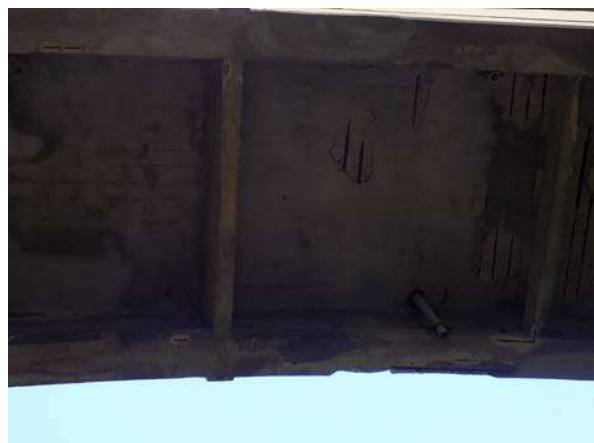
Photo 3: Underside of deck with delaminations

Based on our cursory site visit, there has not been any significant change in the condition of the bridge since the 2015 inspection. Many of the conditions noted in the field are a combination of failures of previous patch work and poor construction practices. The deck delaminations appear to be due to a lack of concrete cover over the reinforcing steel. This is evident in that the reinforcing bars are still bonded with the concrete for the majority of the circumference of the bars. While section loss of the steel may be present, the amount of loss is most likely not significant. Therefore, cleaning and rehabilitating several of these areas with the exposed reinforcing is a viable option as long as the material testing of the concrete concludes these types of repairs are compatible.
